# Manhole Inspection Summary

Manhole # **S15GG\_018MH**

Insp Date: **9/20/07 9:23 AM**

**Location** Address: **2527 BAKER ST**

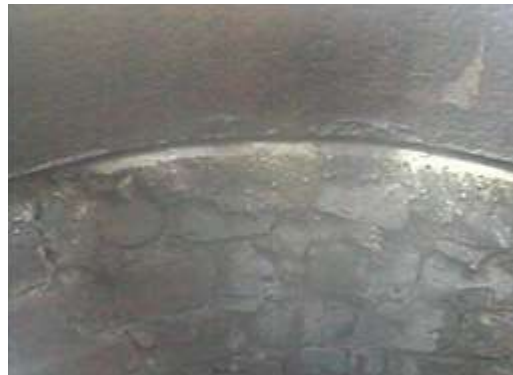
Defect 1

Count: **6** Missing: **1** ☒ **Corroded**

CORRODED / MISSING RUNG

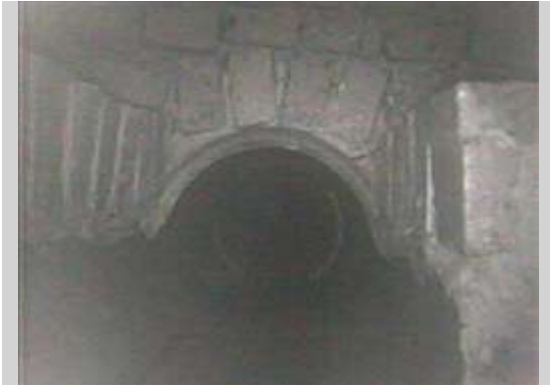
12 O'Clock Outflow

10 in. Circular Gravity Sewer  
Pipe Out @ 12 O'Clock

Pipe Height: **7.2** (in.) Rod and Bar  
Pipe Material: **Clay** ☐ Pipe Lined  
Invert Depth: **9.81** (ft.) Flow Characteristics: **Fast**  
Deposits: ☒ None ☐ Mud ☐ Sludge ☐ Debris ☐ Grease  
Silt Depth: (in.) Deposits Extent:  
Infiltration: **None** Pipe Seal Cond: **Sound**

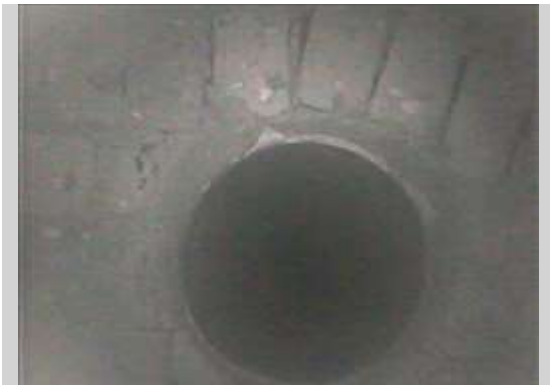
3 O'Clock Inflow

10 in. Circular Gravity Sewer  
Pipe In @ 3 O'Clock

Pipe Height: **7.2** (in.) Rod and Bar  
Pipe Material: **Clay** ☐ Pipe Lined  
Invert Depth: **6.42** (ft.) Flow Characteristics: **Fast**  
Deposits: ☒ None ☐ Mud ☐ Sludge ☐ Debris ☐ Grease  
Silt Depth: (in.) Deposits Extent:  
Infiltration: **None** Pipe Seal Cond: **Sound**

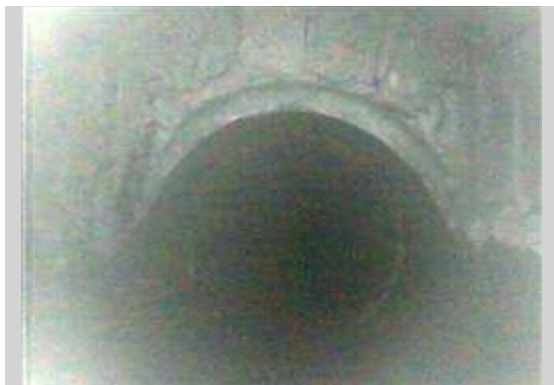
6 O'Clock Inflow

10 in. Circular Gravity Sewer  
Pipe In @ 6 O'Clock

Infiltration: **None** Pipe Seal Cond: **Sound**
